TERMINAL TREATMENTS
FOR
ILLINOIS CONTINUOUSLY REINFORCED CONCRETE PAVEMENTS

Jagat S. Dhamrait and Richard K. Taylor

Interim Report
IHR-36
Investigation of Continuously Reinforced Concrete Pavement

June 1977

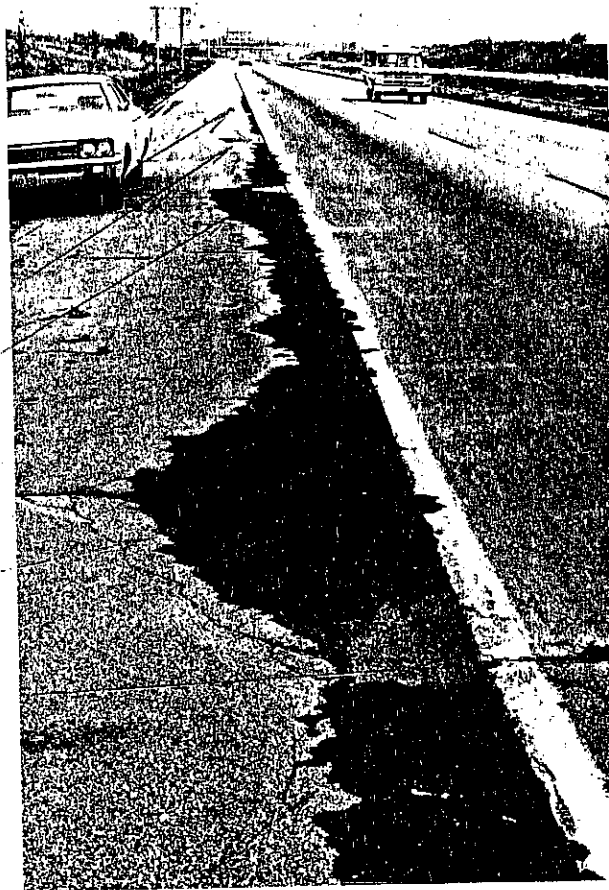
Figure 16. Distressed Anchor System Before Excavation

The excavation revealed that voids about 6 to 12 in. (152 mm to 305 mm) in width had formed in the subbase adjacent to either side of each lug wall. These voids extended back along the lug walls at least five feet under the pavement. Relatively narrow voids were found to extend down along the interfaces of the lug walls and embankment. Between the lugs, a gap varying from $\frac{3}{8}$ to $\frac{3}{4}$ in. (9.5 to 19 mm) between the pavement and the subbase was observed. The pavement between lugs

deflected under traffic loads due to a lack of any subgrade support. It was noted that the upper surface of the cement aggregate mixture (CAM) subbase in the void between the pavement and the subbase had developed signs of ravelling. The degree of distress was highest near the end lug and diminished with distance from the pavement end.
